# **Cairngorm funicular railway:Supplementary written submission from Gordon Bulloch, 8 January 2026**

## Cairngorm Funicular – the problem of tilting of the support pillars (pillar rotation)

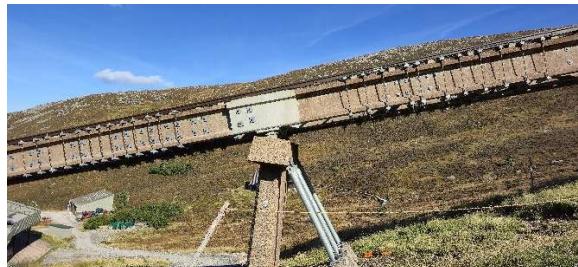
Steel struts installed on the uphill side to limit pillar rotation

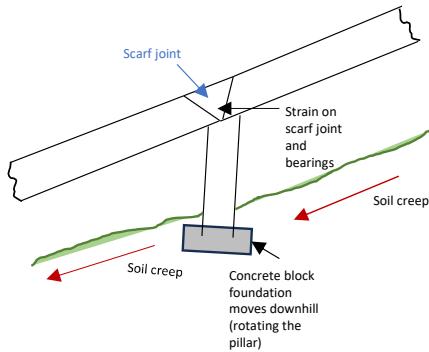
Fig 2: Pillar rotation – part of reason for closure in 2018

1. All except up to about 6 of the 92 funicular structural pillars have foundations which float within the glacial till. If the pillars had been founded on bedrock, then pillar rotation would not have occurred.
2. The glacial till found in Coire Cas is granular and porous, resulting in considerable groundwater flow which exacerbates soil creep.
3. There is a known problem that much of the bedrock is broken and crumbling due to weathering, including effects of water erosion over the millennia. Consequently, fixing to sound bedrock would have been very difficult and expensive.
4. From the evidence available, it seems that geotechnical investigations undertaken to technically support the funicular design were inadequate. COWI did undertake some minimal geotechnical investigations prior to the major repairs which commenced in 2020.

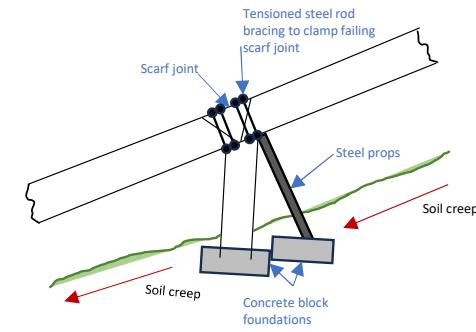
Fig 3: Repair solution designed to prevent further pillar rotation

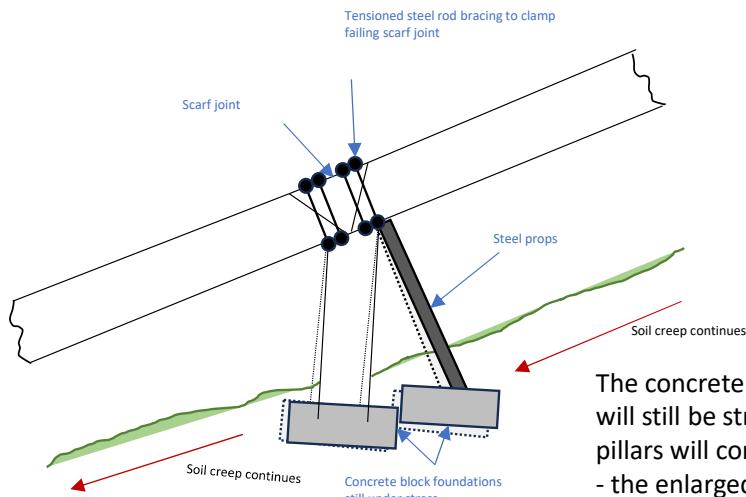
Fig 4: Continuing issues after repairs to limit further pillar rotation

The concrete foundations of the pillar and steel props will still be stressed by soil creep, and is likely that the pillars will continue to rotate although:

- the enlarged concrete foundation will offer more resistance and slow the process down
- the steel prop will reduce, but not eliminate the downward moment (perpendicular to the beams carrying the funicular track) caused by pillar rotation. Continued stressing from soil creep will continue to increase stress on the scarf joint and the tensioned steel bracing.
